Report on the Escape of Prisoner
MICHAEL DAVID ELLIOT

From the Ionia Correctional Facility
On Sunday, February 2, 2014

PREPARED BY
THE MICHIGAN DEPARTMENT OF ATTORNEY GENERAL

July 21, 2014

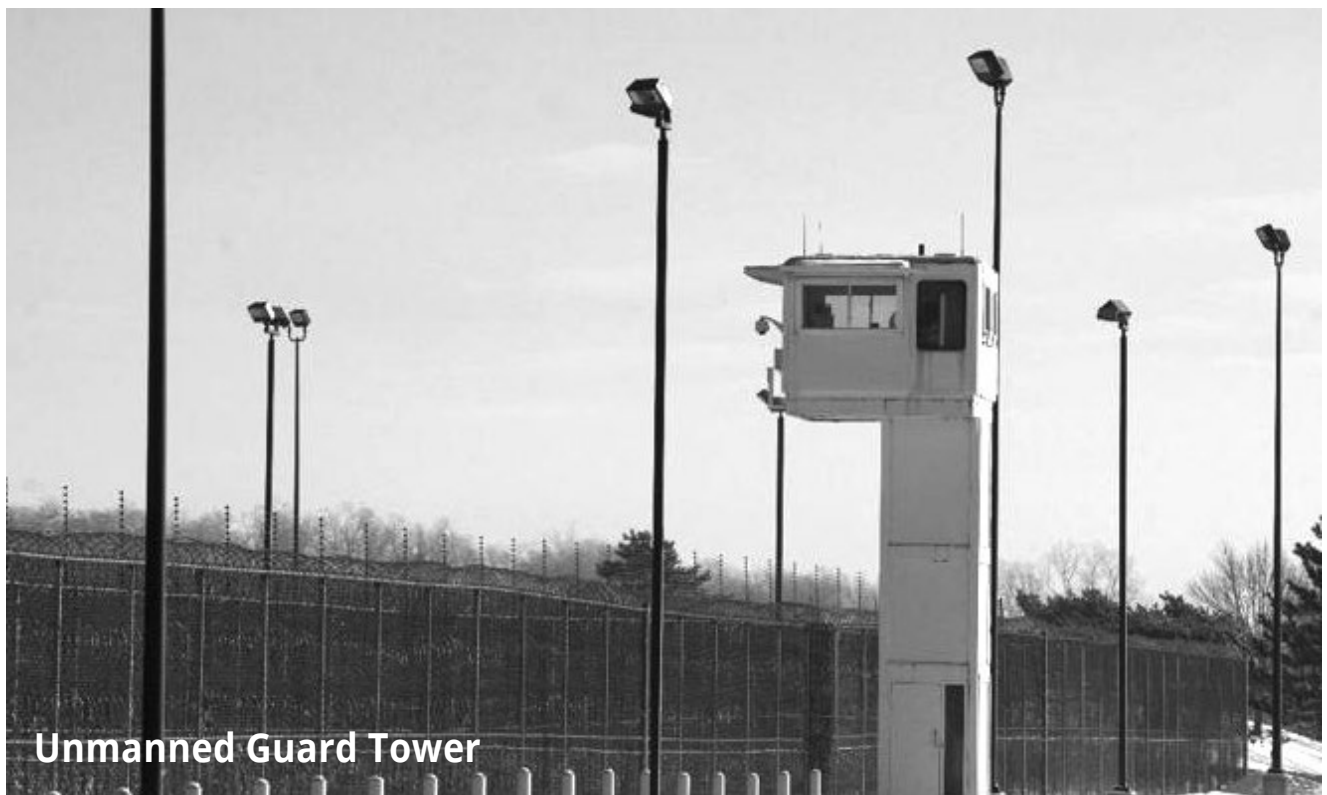
Unmanned Guard Tower

There are five observation towers surrounding the perimeter of the facility. In July of 2013, MDOC eliminated the placement of armed officers in these towers.

MDOC must reconsider whether to station armed officers in the guard towers to achieve a sufficient deterrent effect on prisoners considering escape attempts.

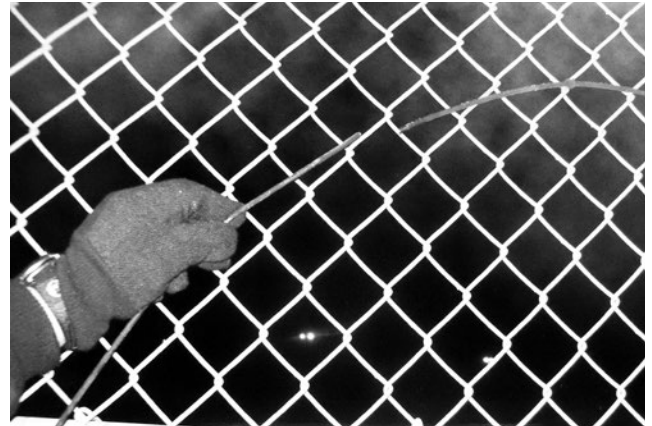
Additional fencing, called the slow-down fence, separates the prison buildings from the recreation yard. The fencing runs down a sloping field. This fence contains a cable that was once part of an E-Flex wire alarm system. E-Flex is an intrusion alert system designed to detect penetration through the chain-link fabric of a fence. An alarm is set off whenever someone physically pulls or tugs on the chain-link fabric. The E-Flex cable in this fence has not been operational for more than seven years.

Broken E-Flex wire.

The E-Flex wire alarm system contained in the interior slow-down fence must be restored to operation as it is the first structural line of defense.

tional for at least seven years. Had this system been operational it would likely have activated the fence alarm as Elliot reported that he got caught on the bottom fencing as he crawled underneath it. The failure of ICF management to have this system operational is a significant contributing factor in Elliot's escape.

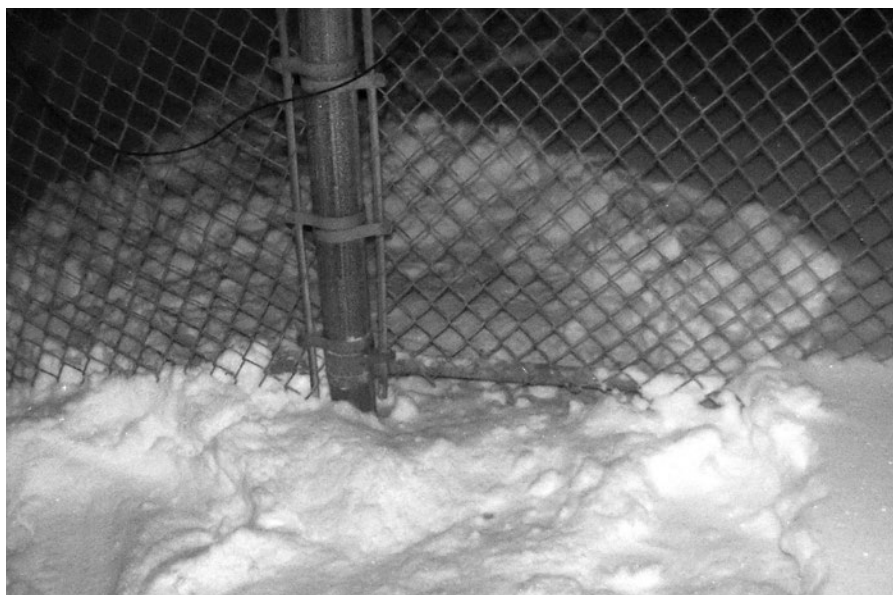
Elliot's path under the slow-down fence.

Elliot reported that he had a difficult time getting through the gap under the fence. He used the metal clothes hook to clear away the snow and chip ice to make the gap wider. He then crawled on his belly and squirmed through the gap under the fence. Once Elliot made it through the slow-down

All slow-down fences must be inspected and repaired to ensure that there are no gaps or structural weaknesses. It is also recommended that slow-down fences be established that would limit inmate movement to areas that are within the observation of the assigned yard officer.

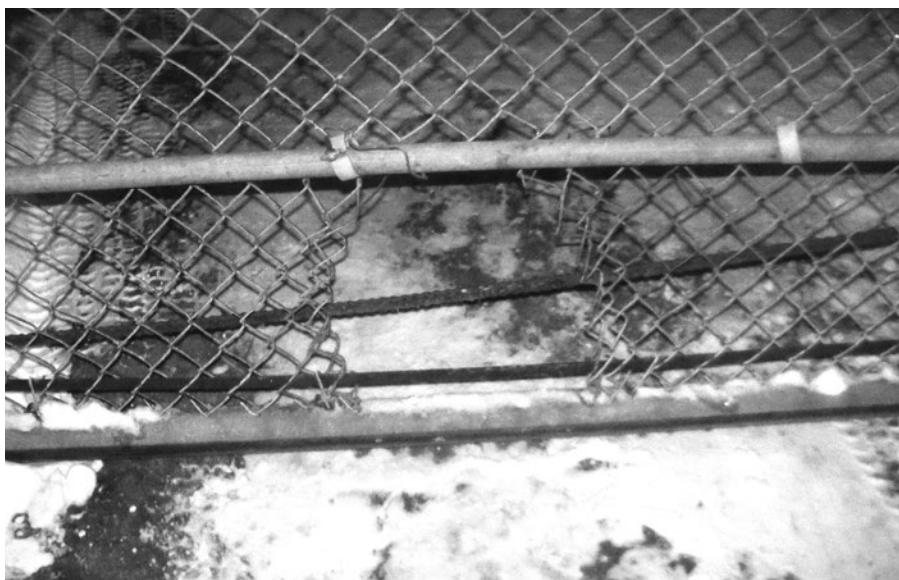
Fence unraveled by Elliot.

Upon reaching the sally port inner gate, Elliot rolled on his back and began working on the fence. He used the scissors to pry open bends in the fence strands surrounding the bottom wire holding the fence in place. He then unraveled each strand approximately 24 inches from the bottom of the fence. Using his belt and buckle to pull the unraveled strands to the side, he enlarged the hole. A video recording shows that by 6:39 p.m. the hole was big enough for Elliot to crawl through the separated fabric and enter the sally port area.

The sally port gate fencing must be firmly secured to its frame to prevent the unraveling of the chain-link fabric.
